# Manhole Inspection Summary

Manhole # S11YY\_005MH

Insp Date: **8/18/08 9:21 AM**

**Location** Address: **3536 WHITE CHAPEL RD** Cross Street: **BARRINGTON RD**

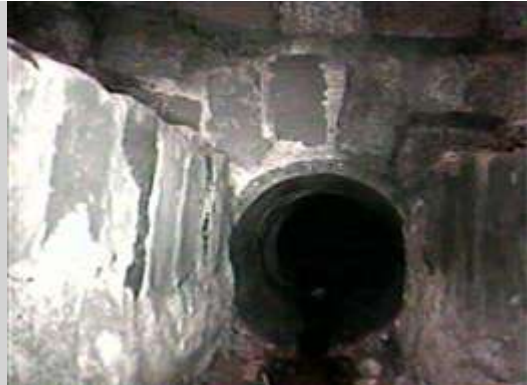
12 O'Clock Outflow

8 in. Circular Gravity Sewer  
Pipe Out @ 12 O'Clock

Pipe Height: (in.) Direct  
Pipe Material: **Clay** ☐ Pipe Lined  
Invert Depth: **7.25** (ft.) Flow Characteristics: **Slow**  
Deposits: ☒ None ☐ Mud ☐ Sludge ☐ Debris ☐ Grease  
Silt Depth: (in.) Deposits Extent:  
Infiltration: **None** Pipe Seal Cond: **Sound**
